A STUDY OF SHELTERS FOR THE URBAN HOMELESS (SUH) IN AHMEDABAD

(FINAL REPORT)

Citizens for Shelter Alliance, Ahmedabad (CISHAA)

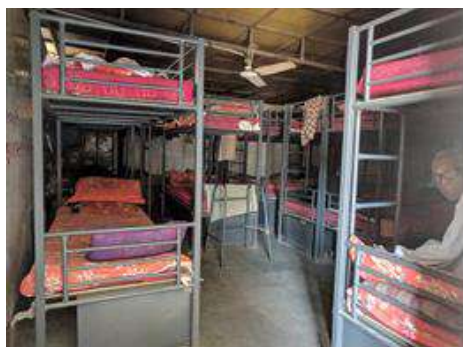
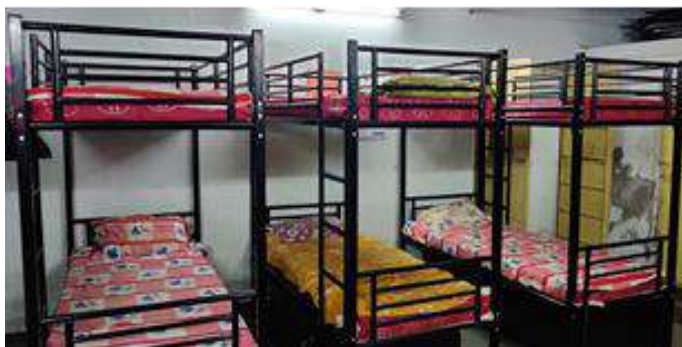
Photo 2. New bunk beds provided by AMC in the shelters

Furthermore, during the second visit to the shelters for taking photographs in February 2020, it was noted that AMC has been implementing bunk beds in the dormitories. While this step will increase capacity, it will place a strain on other resources such as cooking facilities and open space that are already falling short of the residents' needs. Furthermore, the provision of recommended minimum space of 50 sq. ft. per person as per the SUH guidelines will also become more difficult.

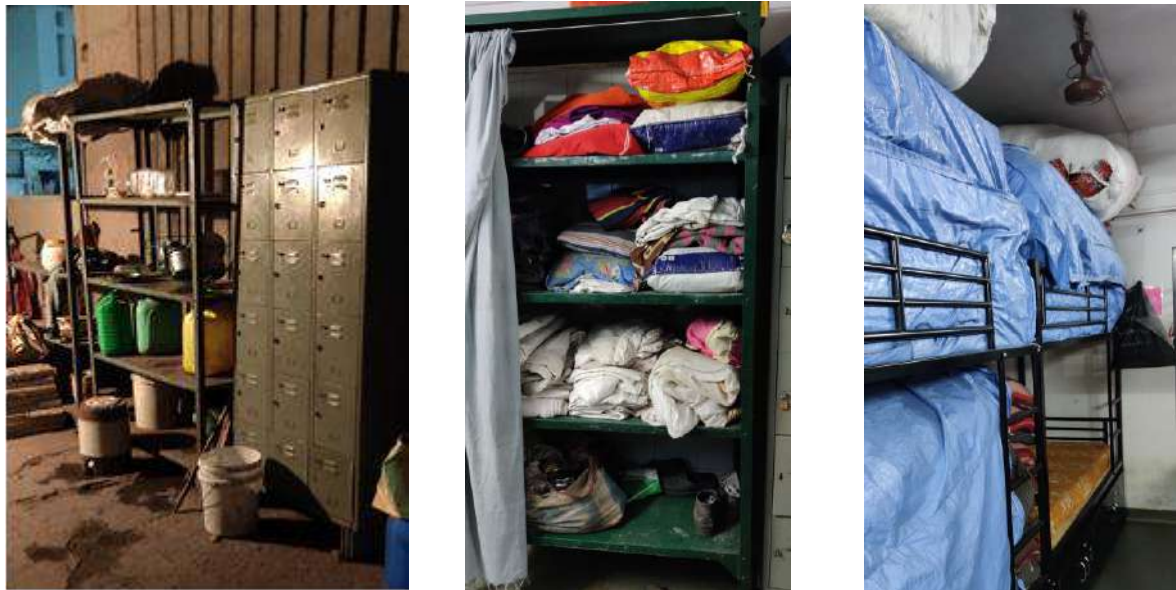
Photo 4. Almirahs and Functioning of Storage Spaces provided in the Shelters

- In terms of secure storage facilities, lockers for storage were provided in all the dormitories in 22 shelters. In 1 shelter, there were no lockers (Shelter near Ghatlodiya UHC). While AMC had begun to provide lockable almirahs, this provision was found in only 8 of the 23 shelters – in 7 shelters, each of the dorms had one or more lockable almirahs, while in 1 shelter only one of the two dorms had a lockable almirah.

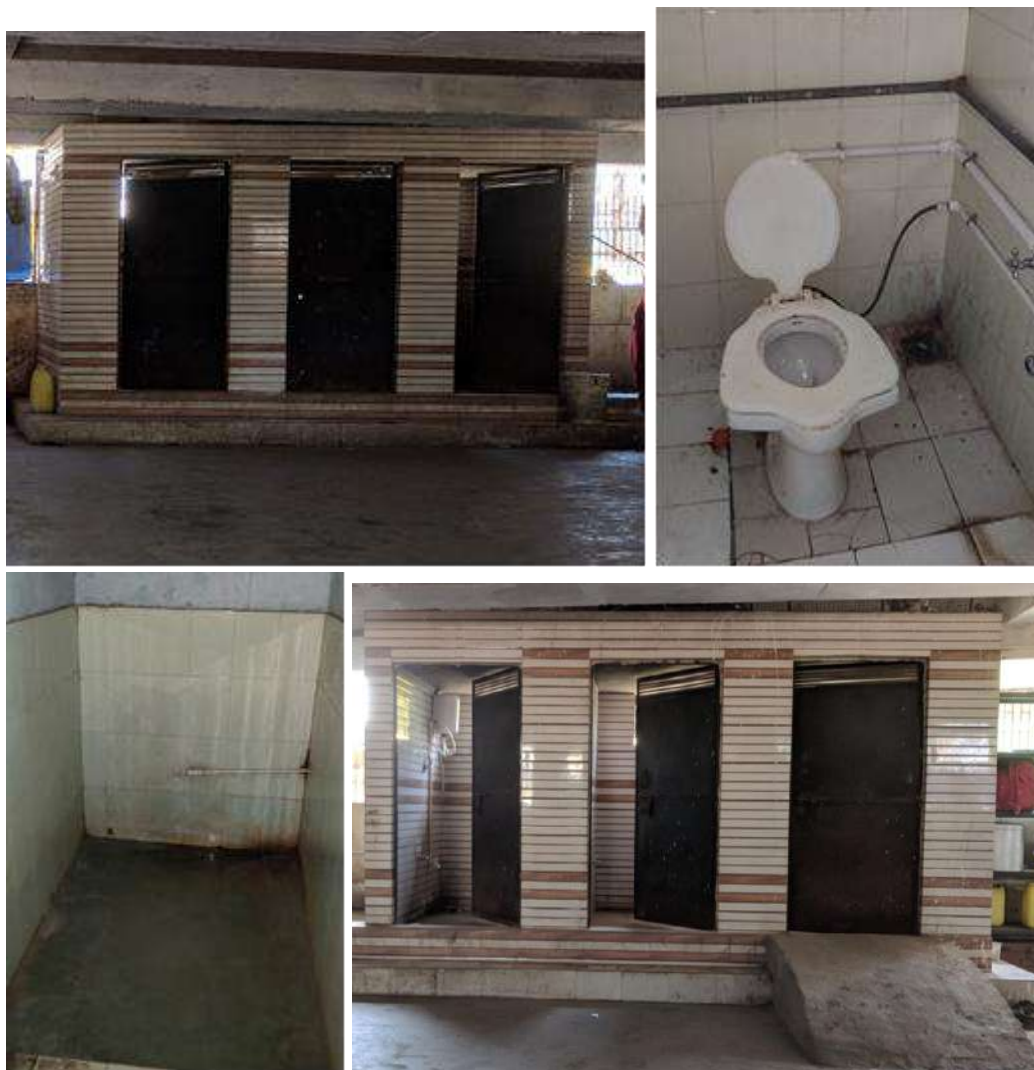
Photo 5. Present Toilet / bathroom scenario

- There are no separate spaces for washing clothes and utensils, and it was observed that the shelter residents either washed clothes in the bathrooms or in the open spaces of the shelter premises. This also meant that the bathrooms were not adequate as they doubled up as spaces to wash clothes. Utensils were washed in the open spaces of the shelter premises, creating puddles of water. There was also no provision for drying washed clothes, and residents had put up clothesline in and around the shelter, which created difficulties in the monsoon.

- The toilets/bathrooms as well as the remaining areas of the shelter were found to be in largely good or satisfactory condition of cleanliness in all the 25 shelters.

4. *Sanitation:* At several shelters, the shelter staff have reported issues with plumbing repairs and maintenance, overflowing toilets / sewers, garbage disposal and cleanliness. We recommend that AMC look into these issues and strengthen the system through which the shelter staff can make complaints as well as strengthen their systems for quickly resolving these issues when a complaint is received. Better still would be for organizations to manage those at their level, for which the AMC must provide budget. Awareness activities for better cleanliness as well as proper formation of Shelter Management Committees at the shelters can also help in encouraging shelter residents to maintain better cleanliness. It was observed that in some cases bathrooms were used to wash clothes and vessels. This caused inconvenience and unclean baths. Special *chokdis* for washing clothes and vessels must be structured into the design. And so also covered shed for drying washed clothes. The adequacy of the toilets to the ratio of residents has not been recorded. Yet as this did not come up as a major problem shows that this may not be the case. In a few shelters access to all available toilets was restricted as it was locked for staff use, or was broken or used for storage. This must be urgently corrected as access to toilets is a necessity and also part of the ODF program.

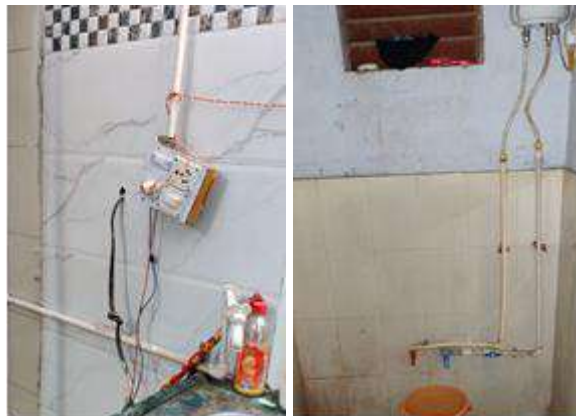
Photo 6. Present Electric fixtures and points provided in the Shelters

- In the shelters which had common areas like corridors, there was 24-hour electricity provision in these common areas, however, in a couple of these shelters the light fixtures were not working properly.

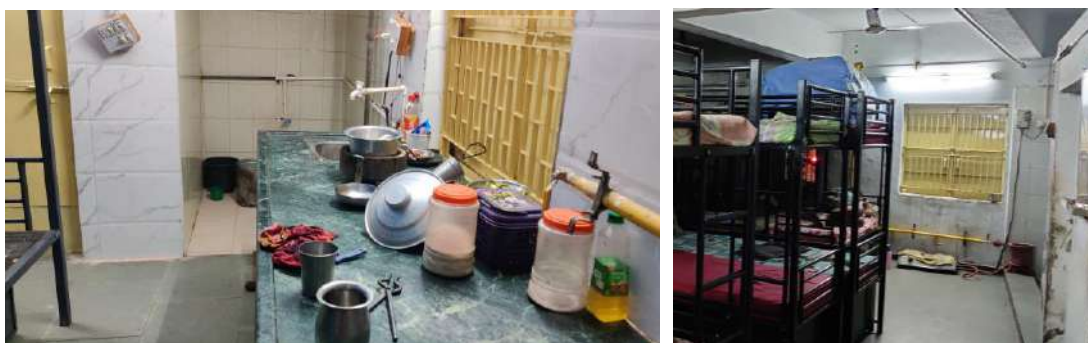
Photo 7. Provision and usage inside the Kitchens

In the 3 shelters which had a gas connection, how were the kitchens being used? It was found that in only one shelter, residents were allowed to use the kitchen, while in the other two shelters only the managing organisation was permitted to use the kitchen.

Residents at 1 shelter which had a separate room for kitchen but which they were not permitted to use (since it was not ready for use) specifically expressed that they were waiting for the gas connection and gas burners to come so they could use the kitchen (one of the shelters under Midco bridge, Vatva). Data on provision of utensils was collected in 21 of the 25 surveyed shelters. All these shelters were found to have utensils. Note that in most of these shelters, there is no separate room for kitchen, there is no separate room for kitchen but utensils have still been provided. In some cases, residents were still using the utensils to cook / eat elsewhere in the shelter, generally in / around the shelter compound. Observations revealed that besides the plates, the cooking utensils themselves are large and therefore not appropriate for families / small groups to use.

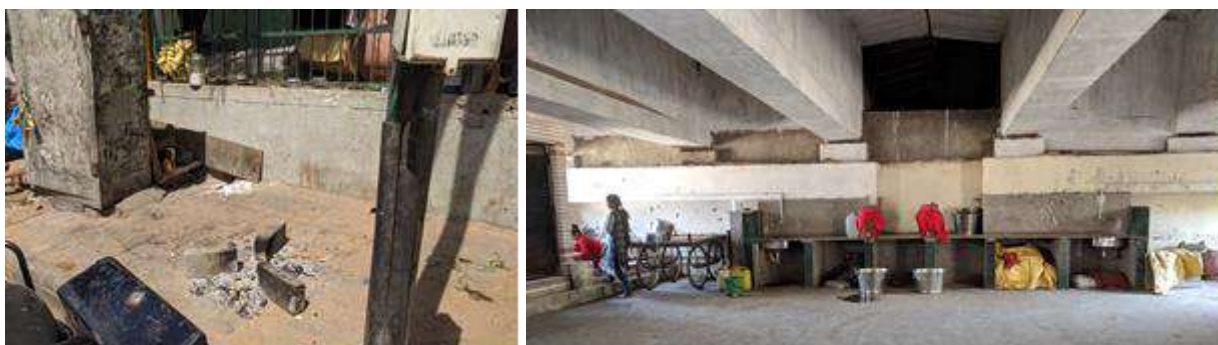
Photo 8. Cooking facilities and usage near the Shelter

Majority of residents who were cooking in these other spaces were using wood as cooking fuel.

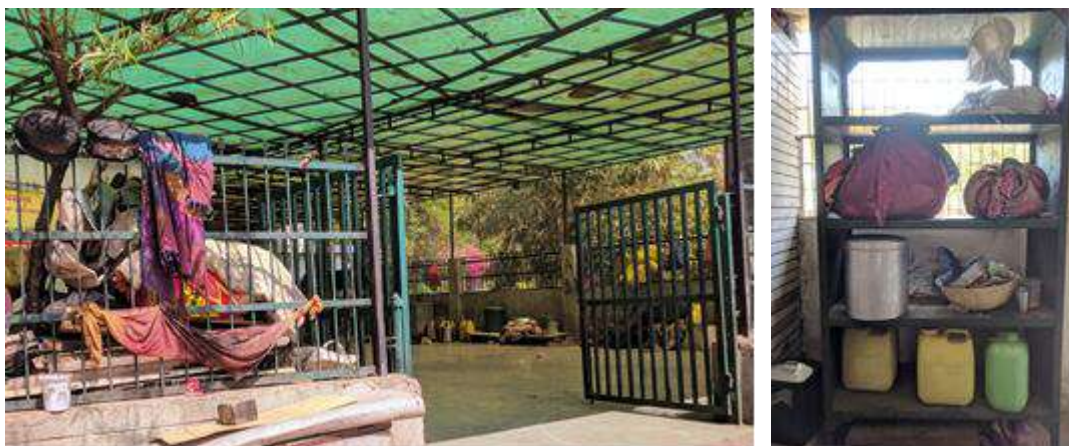
Photo 9. Compound space of the Shelters

Approximately 15 of the 25 surveyed shelters have a shelter compound with some kind of open space within this compound while a few of these shelters also have an accessible roof. Among the remaining 10 shelters, a couple of shelters have an accessible roof.

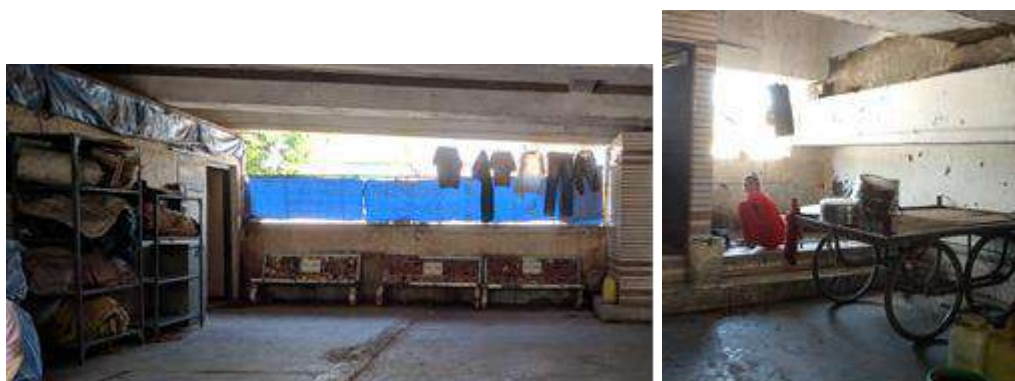
Photo 10. Activities happening in the Open Space of the Shelters

Shelters designed underneath flyovers have no open spaces attached to them. Cooking food is the most common activity for which the open spaces, specially the ones on the ground floor, are being used. In 11 out of 25 shelters, the space was used for cooking at some or the other point in the year. Several families use the open spaces available to sit during the leisure time. Seasonal changes in the use of the space were reported in several shelters. In the summer, other than cooking of food, following uses were reported:

- Shelter near India Colony and Shelter under Keshav Nath Bridge – Sleeping on the terrace
- Shelter near Jhansi ki Rani, Shelter below Nathalal Jagadiya Bridge, Maninagar, Shelter near Vastral Ring-Road Cross, Shelter Below CTM Bridge – Sleeping in the yard
- Shelter near Sola Cross Roads – Drying of clothes

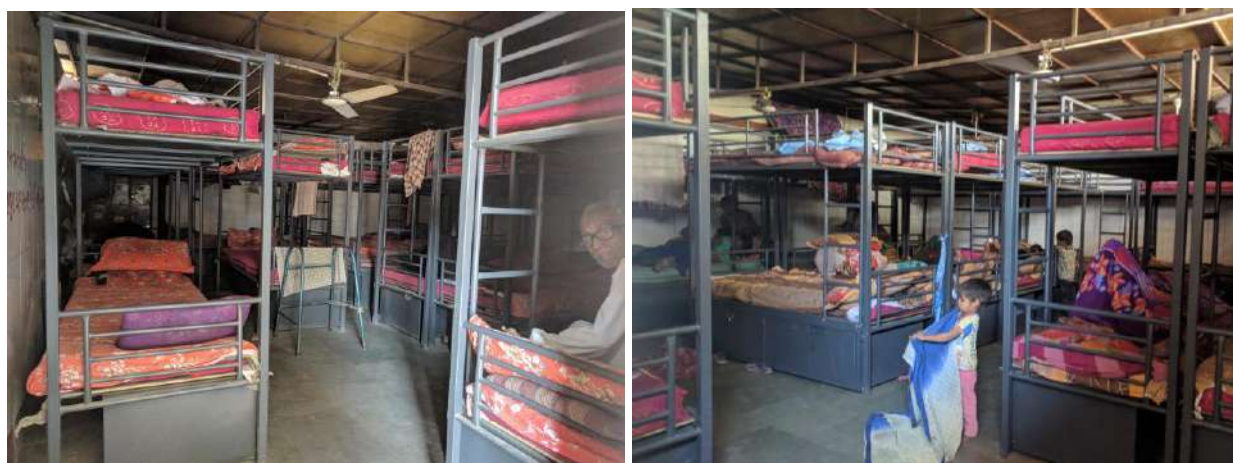
Photo 11. Men and Women's / Women with Children's living separately in the Shelter's

While the adaptability of the operating agencies and AMC in allowing this flexibility should be commended, it should be noted that better shelter designs need to be implemented that can accommodate families directly. The SUH guidelines say that depending on the need, a shelter may cater to working men, women and family with appropriate spaces demarcated for each of the categories.
